AUTOMOTIVE COMPONENT FACILITY (Aluminum) CLEANING RESULTS

December 27 & 28, 2006

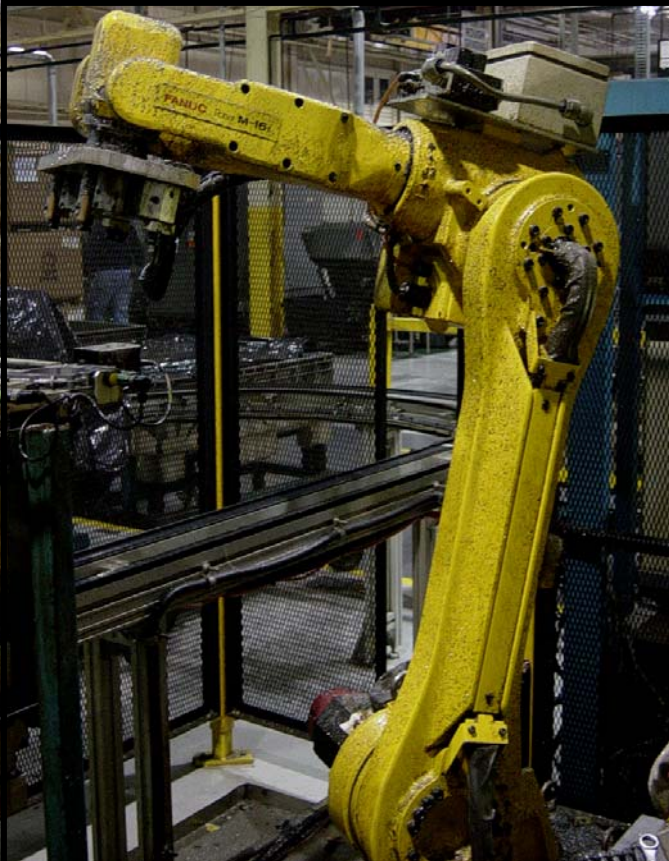
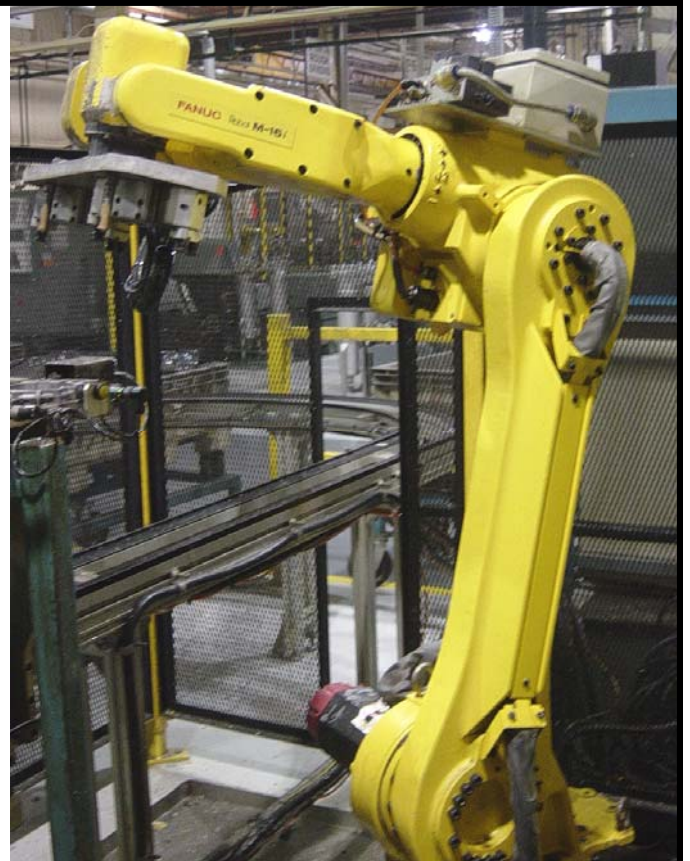
Robots were easily cleaned with the vapor melting the built up lubricant, grime and grease and then blowing the soil to the floor where it can be mopped up or retrieved with a vacuum system. The conveyor belt and conveyor frames were also easily and quickly cleaned. In the future all product and carriers should be removed from the area to allow access to all parts of the conveyor belt and frame.
